FRC ON-SITE AIR BAG DEPLOYMENT INVESTIGATION

CASE NO. 90-7

FLEET - 1990 ACURA LEGEND

LOCATION - [REDACTED], NY

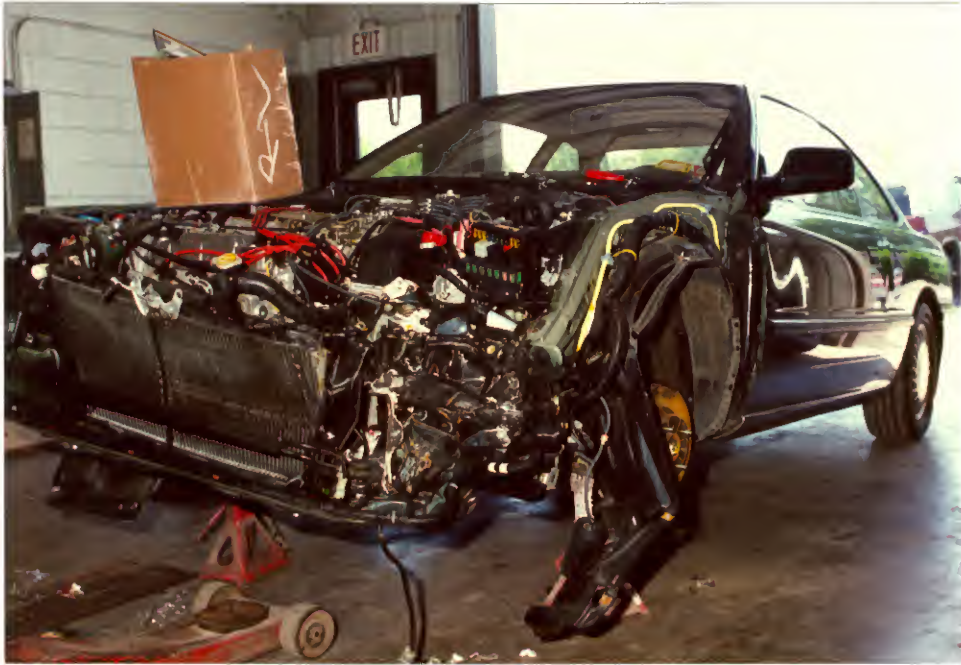
Left Front Three-Quarter View Of The Acura.

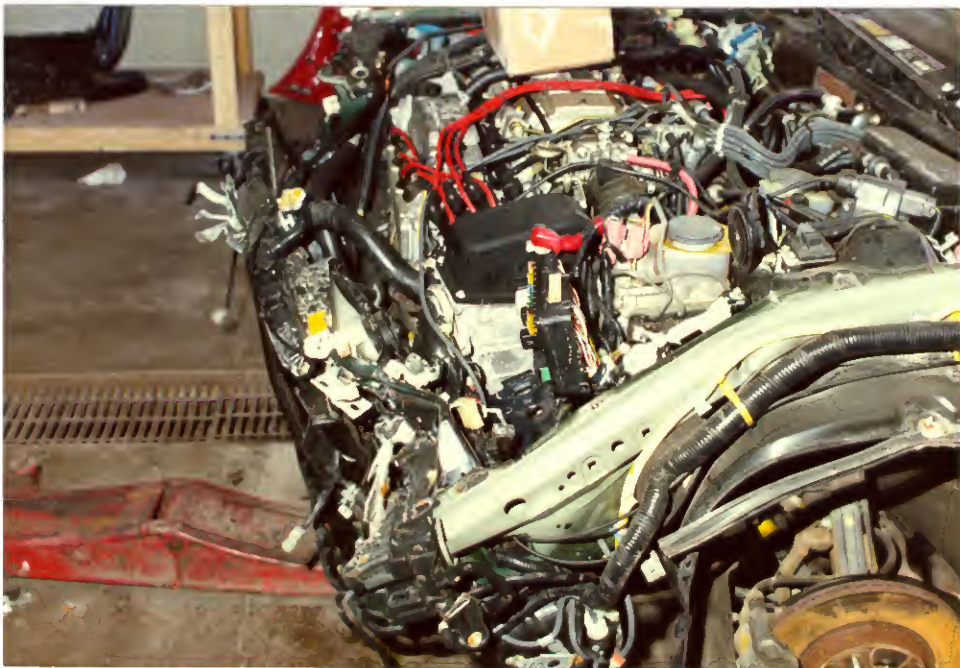
Perpendicular View Of The Frontal Structure.

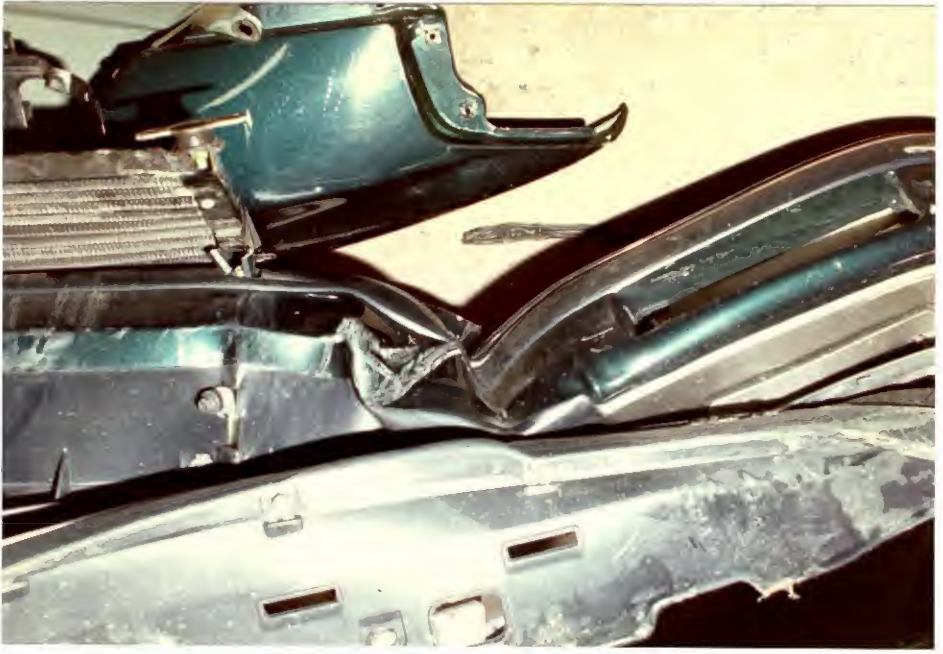
Front Bumper Crush.

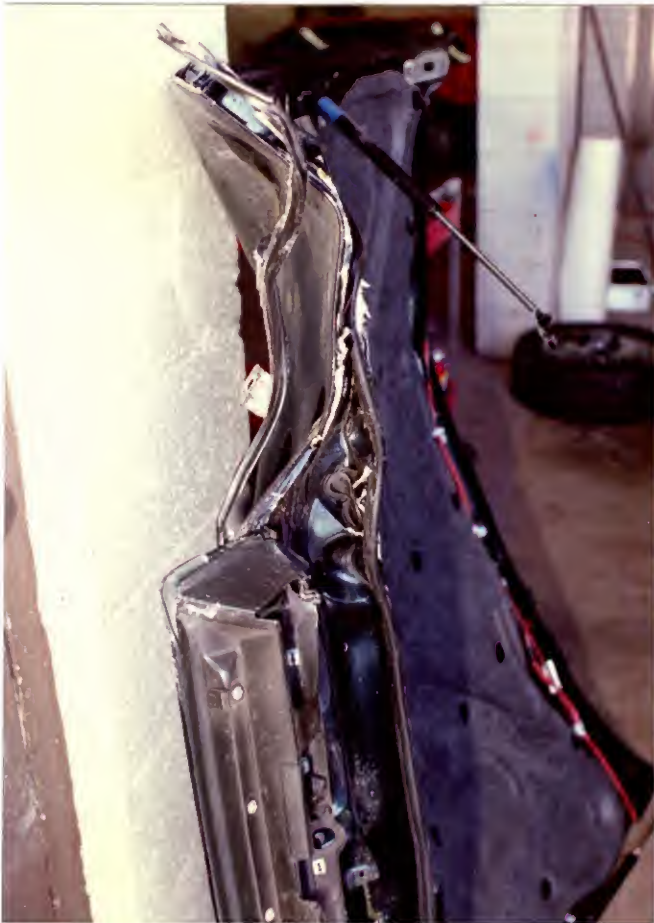
Hood Face Crush.

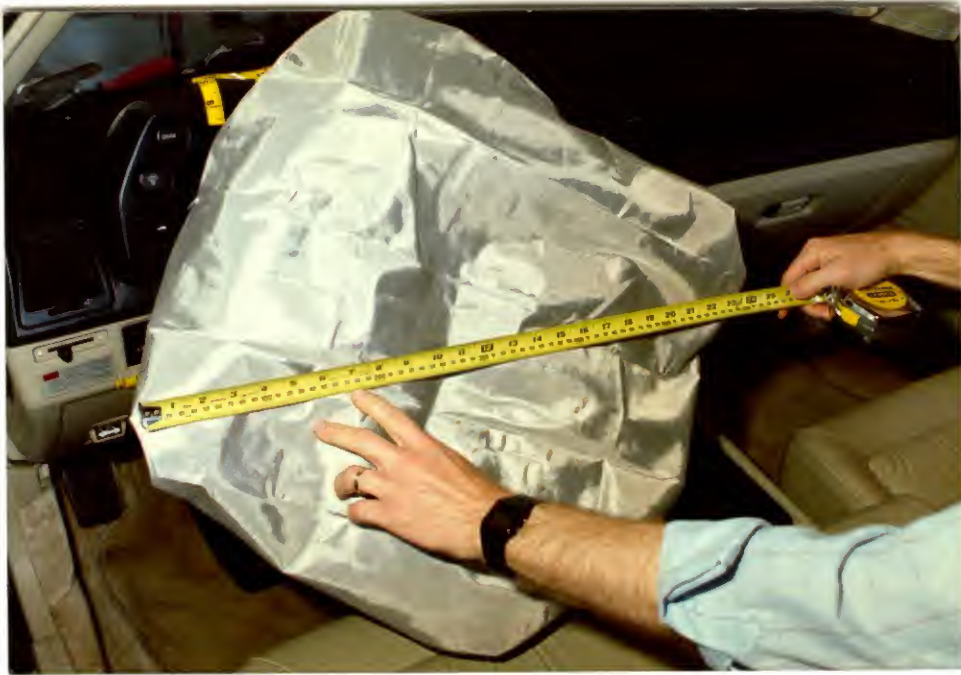
The Acura Legend was equipped with a driver air bag system that deployed at impact. The air bag measured approximately 24" in diameter (deflated state) and was not equipped with an internal tether. The bag was vented through two ports that were 1.25" in diameter located on the inboard edge of the bag (near the inflator) at the 5 and 7 o'clock positions. There was no generant residue deposits in the vicinity of the venting ports. The driver stated that he noted a foul odor within the vehicle immediately following the crash; however, he did not notice smoke or dust within the vehicle.

Deployed Air Bag And Driver Contact Points.

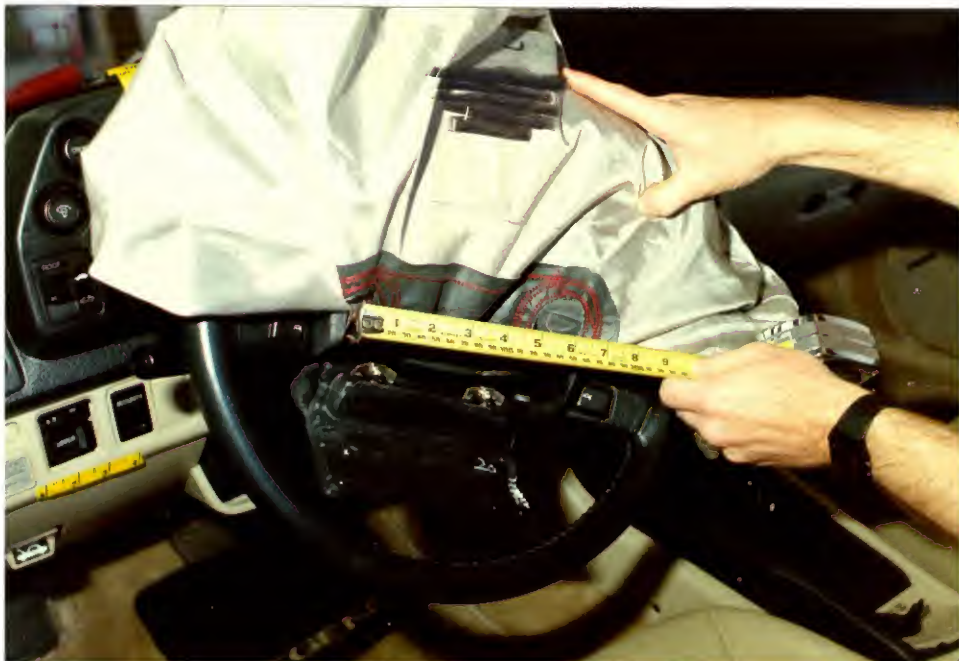
Air Bag Venting Ports.

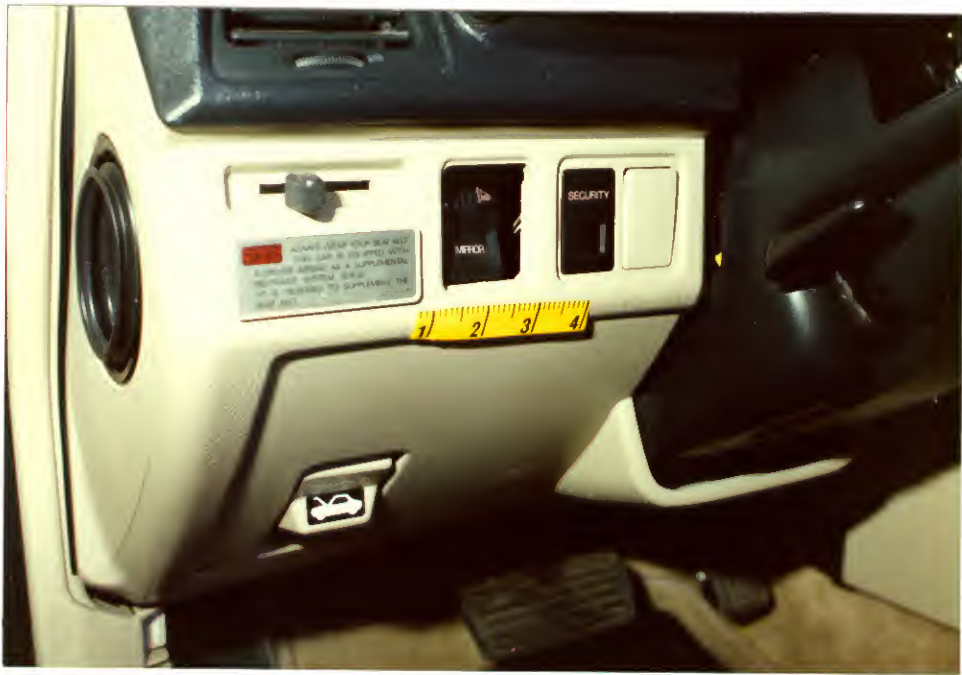
Driver's Left Knee Contact To The Mirror Switch.

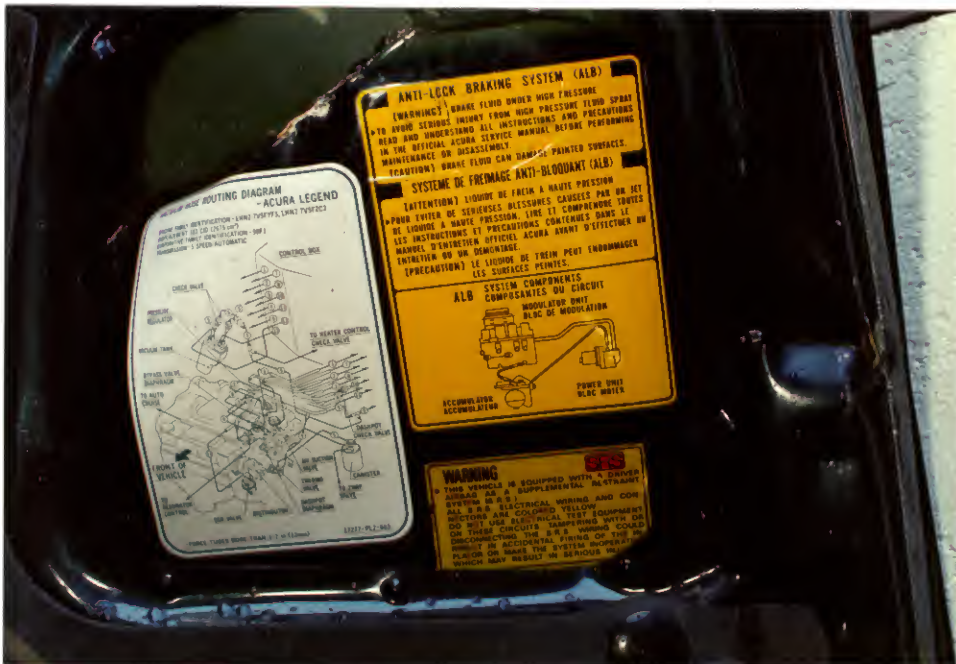
SRS And ALB Warning Labels Affixed To The Vehicle's Hood.

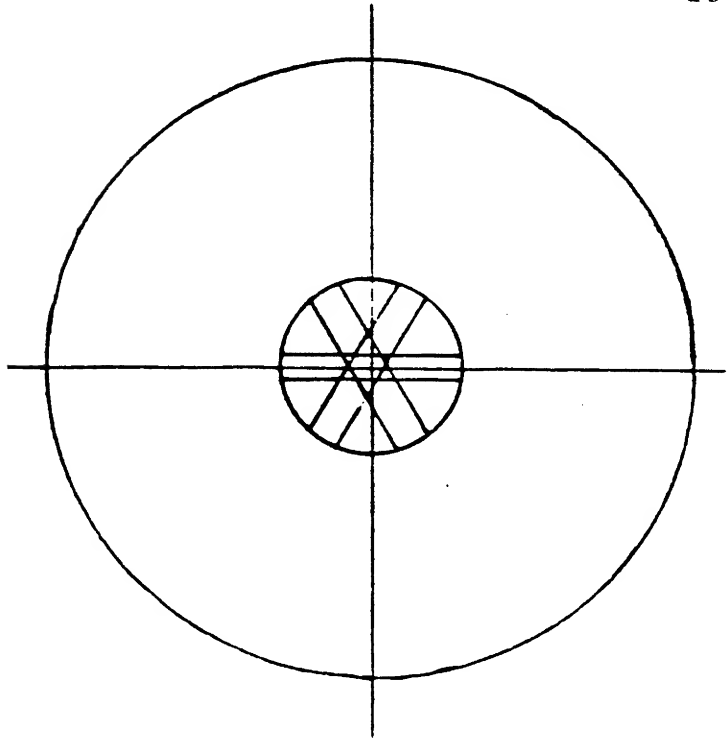
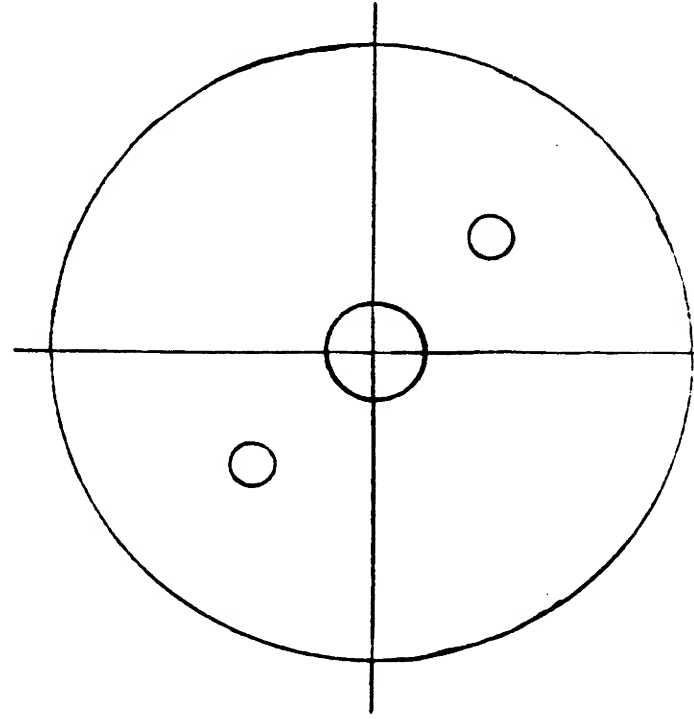
NOTE DAMAGE AND CONTACT MARKS ON AIRBAG DIAGRAMS BELOW:

NO EVIDENCE OF CONTACT

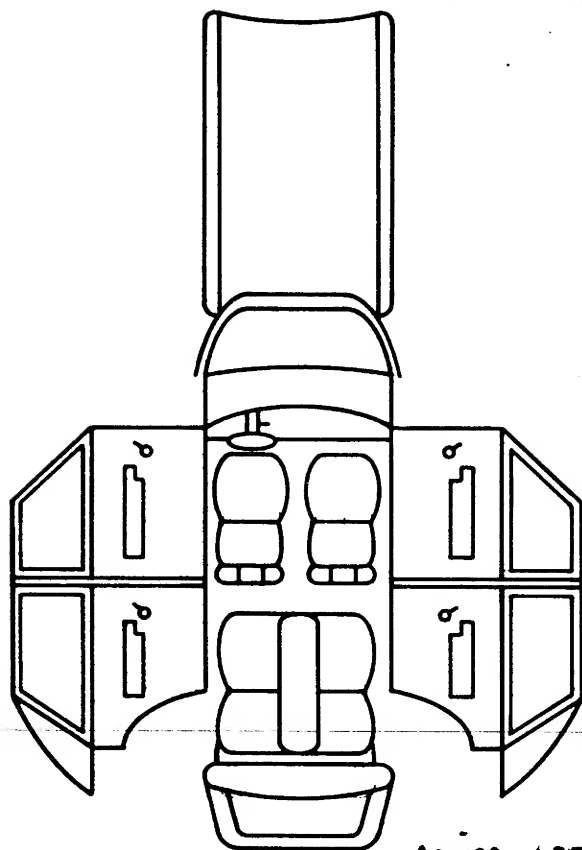
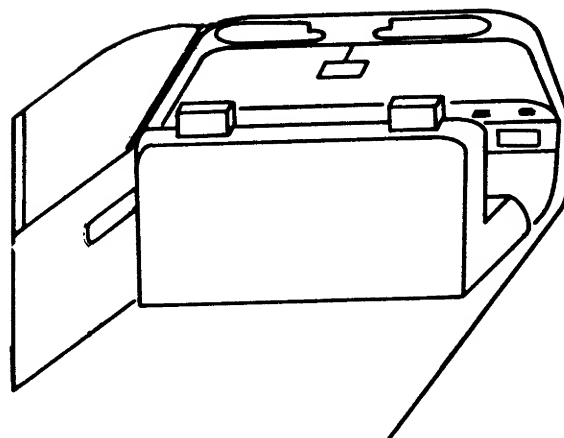
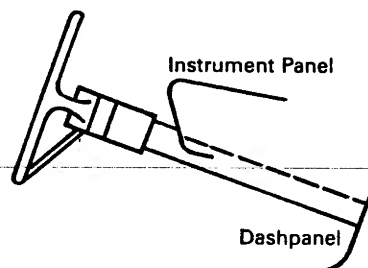
DRIVER LEFT HAND
CONTACT TO UPPER
PANEL, SCUFF

NO EVIDENCE OF CONTACT
TO AIR BAG
